Whitsundays Public Art and Reef Restoration Project

Reef Restoration Monitoring and maintenance

Field Trip Report

Prepared by: Nathan Cook, Reef Ecologic

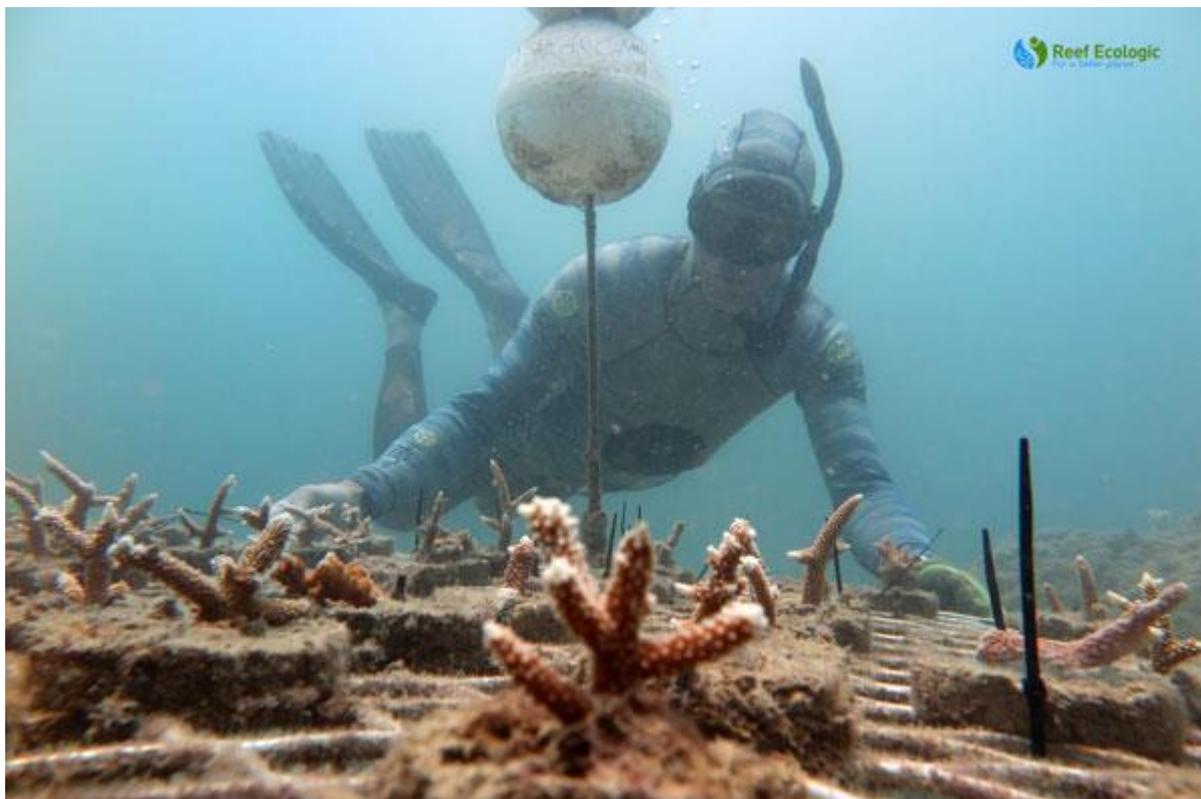
Figure 1: Adam monitoring the coral nursery trays at Manta Ray Bay

Replacing dead or missing coral fragments on the table nurseries.

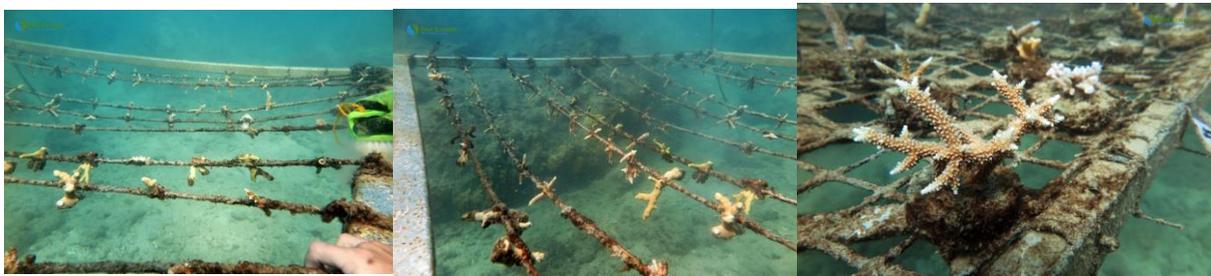
The coral nursery tray had 11 dead or missing coral fragments from original total of 93 representing a reduction of 11.8%. 5 colonies were identified as dead and 6 were missing. Missing fragments suggest ineffective attachment upon propagation. of the missing fragments 4 were attached using silicone and 2 waterproof putty.

The rope nursery had 11 missing fragments from a total of 132 originally propagated representing decline of 8.3%. Many of the fragments on the rope nursery were branching *porities spp* with smooth sides that may be more susceptible to ‘slipping out’ of the rope strands. This observation contrasts with Manta Ray Bay’s rope nursery where all 100 fragments remained attached and alive. (See comments below)

Figure 2: Rope nurseries (Left and centre) and coral on the coral nursery tray (right) at Blue Pearl Bay.

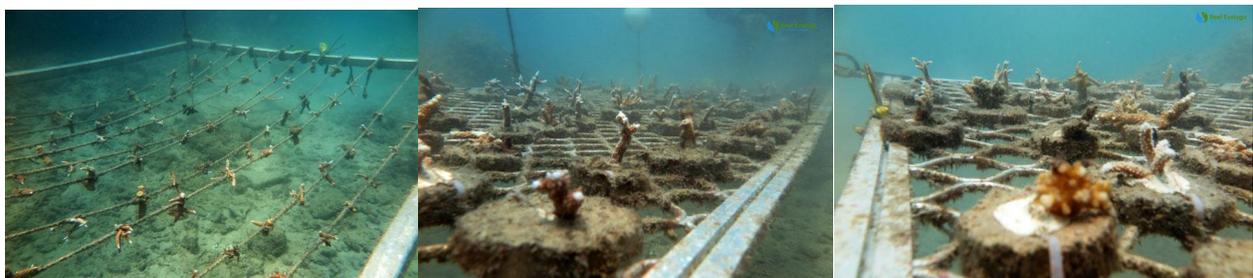
The coral nursery tray had 22 dead (0 missing) coral fragments from original total of 100 representing a reduction of 22%. Explanations for mortality unknown. The coral nursery frames were slightly deeper (7m). The absence of missing fragments suggests more effective techniques due to the use of only experienced staff and volunteers. Of the dead colonies 11 were from corals of opportunity and 11 were from door colonies suggested the method of collection was not a factor. All corals were sourced the Stonehaven Bay. Of the dead colonies there was no difference between those that were propagated using silicone or underwater putty.

The rope nursery had 0 missing or dead fragments from a total of 100 originally propagated. The corals were looking healthy and vibrant.

Figure 3: Rope nursery (left) and coral nursery trays (centre and right) at Manta Ray Bay

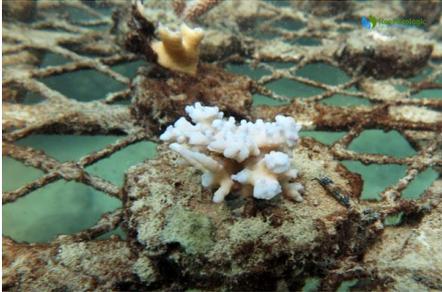
Overall health of the surviving corals on the nursery tray was good. A few (approx. $n < 5$) exhibited signs of bleaching however most were showing good colouration and health. Broken branches from the propagation process had for the most part healed and new branches were evident. Coral growth edges were common on bottom of many colonies where the colony was attached to the fragments plug.

Figure 4: Bleaching *acropora sp* colony.

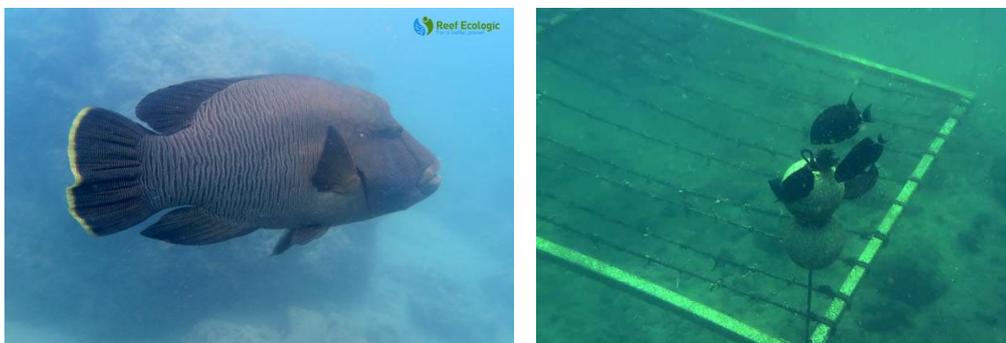
2 large coral trout, tuskfish, surgeonfish and parrotfish were noted around both nursery types in Blue Pearl Bay. The frames themselves exhibited signs of herbivorous grazing with teeth marks present. The slightly deeper nursery tray was home to schools of fusiliers, batfish and 'stripey' snappers.

Manta Ray Bay had fewer fish interactions overall. Inquisitive Maori wrasse visited while we were working but overall interactions were minimal

Figure 5: Inquisitive Maori wrasse at Manta Ray Bay and grazing surgeonfish at Blue Pearl Bay

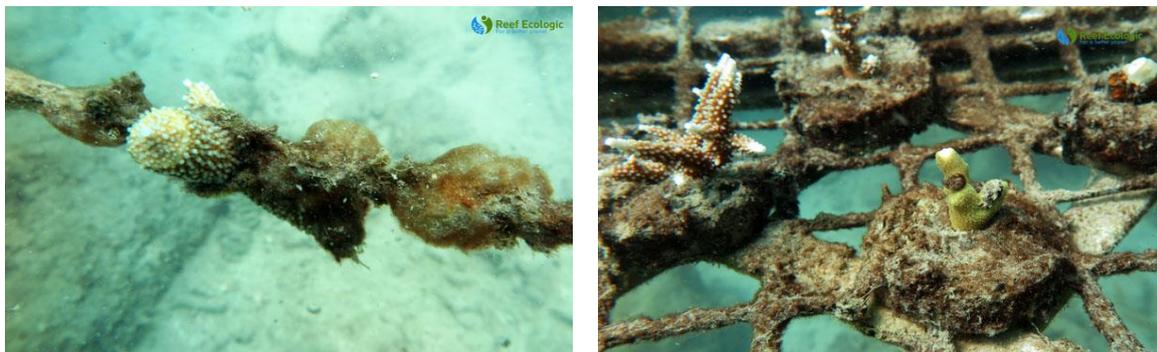
A thick layer of sediment and algae was present on both nursery types however not significantly so. We expected algae and potentially strands of filamentous 'slime' to be growing on the frames however this was not the case. Algae was present but other than where it was compromising some individual colony growth, it did not, on the whole, appear to be compromising the health of the corals.

Algal growth was more obvious in Manta Ray Bay over Blue Pearl Bay. While Manta Ray Bay has an abundance of fish life, primarily it would seem due to the (up to) 10 tourism vessels per day feeding fish near the moorings. We made fewer observations of interactions with marine life at the nurseries in Manta Ray Bay. There were fewer feeding scars or evidence of herbivory.

Figure 6: Sediment coats the rope at the Manta Ray Bay rope nursery (left) while algae is present on the coral fragment discs (right). Both images taken before any cleaning was completed.

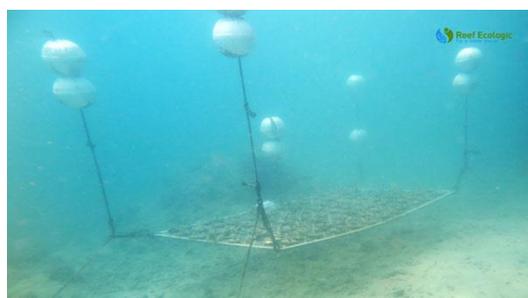
Figure 7: Coral nursery frame at Manta Ray Bay.

The overall condition of the nursery frames was good. All floats were buoyant, all ropes and anchors remained intact and sturdy. Research signage had been overgrown by algae and partially detached. These were cleaned and reattached. We are very pleased with the method.

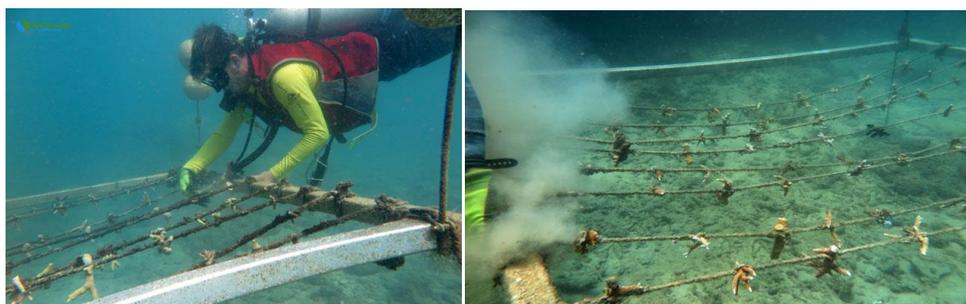
Figure 8: Volunteer cleaning algae off the rope nursery frame.

Staff and volunteers used hands, scrubbing brushes and toothbrushes to clean the coral nursery frames of sediment and algae. Ropes were shaken vigorously before volunteers would run their fingers along the rope to free attached algae. Scrubbing brushes were used to clean buoys, ropes and the aluminium frames and the research signage. Toothbrushes were used to clean around the base of colonies on coral nursery discs and where algae was growing close to the colonies on the rope nurseries.
