Whitsundays Public Art and Reef Restoration Project

Reef Restoration Monitoring and maintenance

Field Trip Report

Prepared by: Nathan Cook, Reef Ecologic

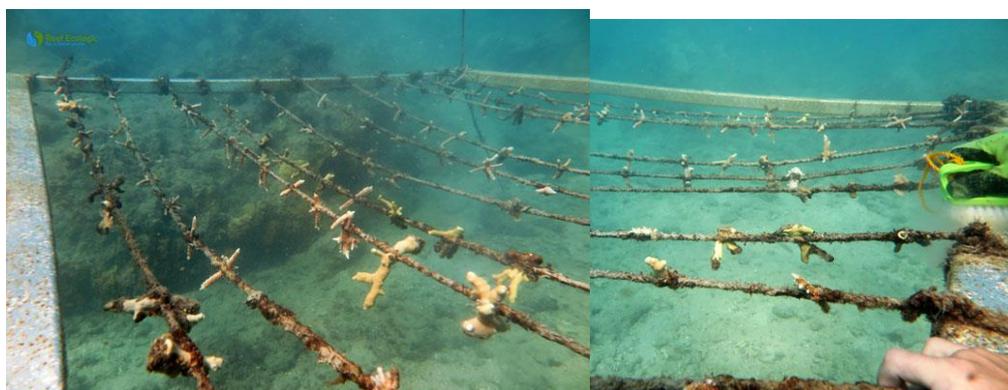
Figure 9: Photo monitoring images rope nurseries, Blue Pearl Bay, 17 Jan 2019.

The rope nursery had 11 missing fragments from a total of 132 originally propagated representing decline of 8.3%. Many of the fragments on the rope nursery were branching *porities spp* with smooth sides that may be more susceptible to ‘slipping out’ of the rope strands. This observation contrasts with Manta Ray Bay’s rope nursery where all 100 fragments remained attached and alive. (See comments below)

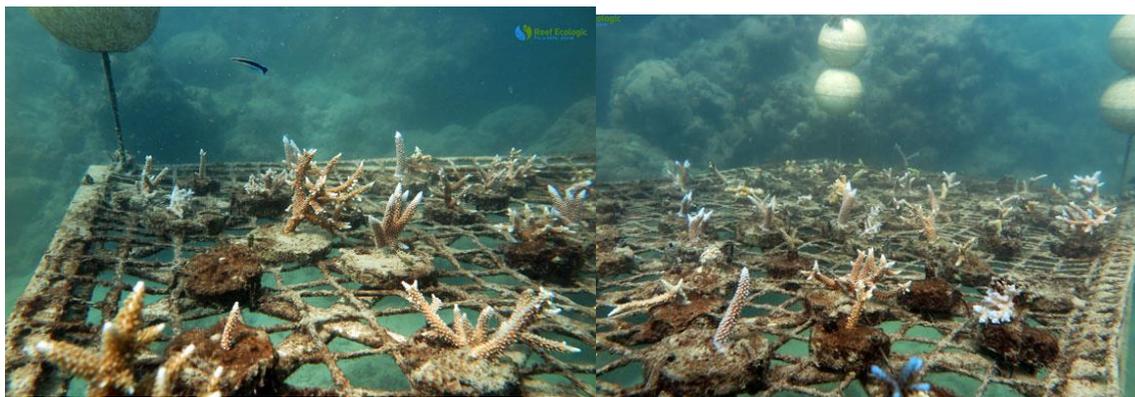
Figure 11: Photo monitoring images from coral nursery trays in Blue Pearl Bay, 17 Jan 2019.

The coral nursery tray had 11 dead or missing coral fragments from original total of 93 representing a reduction of 11.8%. 5 colonies were identified as dead and 6 were missing. Missing fragments suggest ineffective attachment upon propagation. of the missing fragments 4 were attached using silicone and 2 waterproof putty.

Overall health of the surviving corals on the nursery tray was good. A few (approx. $n < 5$) exhibited signs of bleaching however most were showing good colouration and health. Broken branches from the propagation process had for the most part healed and new branches were evident. Coral growth edges were common on bottom of many colonies where the colony was attached to the fragments plug.

Coral fragment discs with dead or missing coral fragments were re-propagated recycling the discs and using corals of opportunity remaining from nursery establishment (excess fragments were left on rocks nearby the nursery frames) or from branches of colonies growing on the nursery. We re-propagated a total of 9 new coral colonies at Blue Pearl Bay and 19 news colonies at Manta Ray Bay. All colonies were of the *Acropora spp* family.

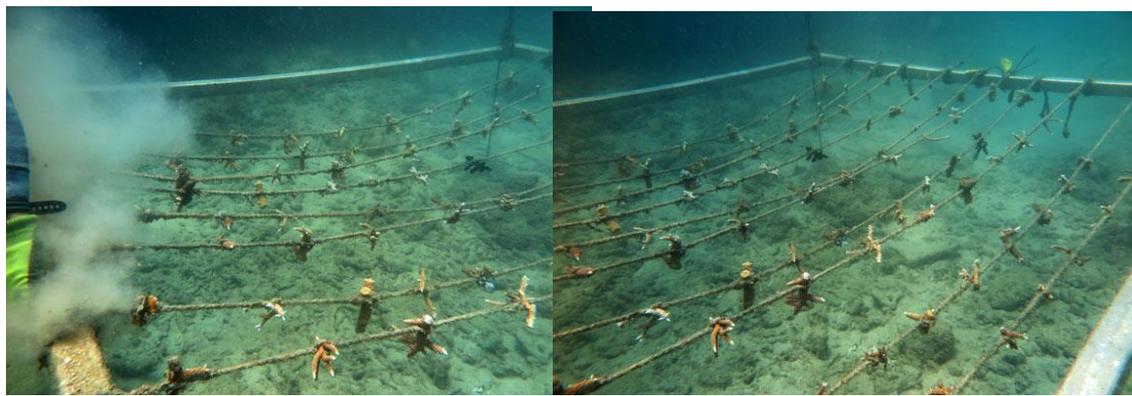
Figure 10: Photo monitoring images rope nurseries, Manta Ray Bay 17 Jan 2019.

The rope nursery had 0 missing or dead fragments from a total of 100 originally propagated. The corals were looking healthy and vibrant.

Corals on the rope nursery in Manta Ray Bay appeared in good condition and surviving colonies on the nursery tray were also exhibiting signs of good health and recovery from the propagation process.

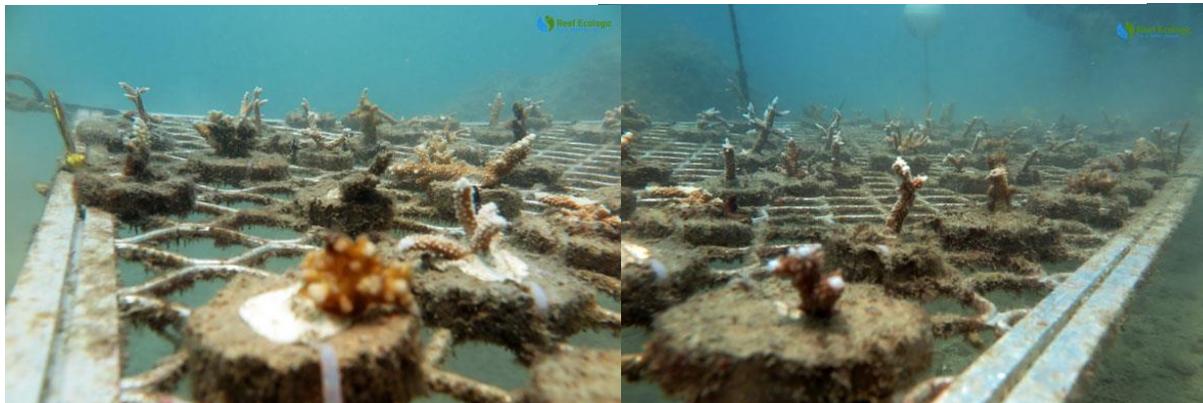
Figure 12: Photo monitoring images coral nursery trays, Manta Ray Bay 17 Jan 2019.

The coral nursery tray had 22 dead (0 missing) coral fragments from original total of 100 representing a reduction of 22%. Explanations for mortality unknown. The coral nursery frames were slightly deeper (7m). The absence of missing fragments suggests more effective techniques due to the use of only experienced staff and volunteers. Of the dead colonies 11 were from corals of opportunity and 11 were from door colonies suggested the method of collection was not a factor. All corals were sourced the Stonehaven Bay. Of the dead colonies there was no difference between those that were propagated using silicone or underwater putty.
